Docket No. 217 – Development and Management Plan Inspection

Northeast Utilities Service Company Certificate of Environmental Compatibility and Public Need for the construction of a 345-kV electric transmission line and reconstruction of an existing 115-kV electric transmission line between Connecticut Light and Power Company's Plumtree Substation in Bethel, through the towns of Redding, Weston, and Wilton, and to the Norwalk Substation in Norwalk, Connecticut.

Date: May 10, 2006

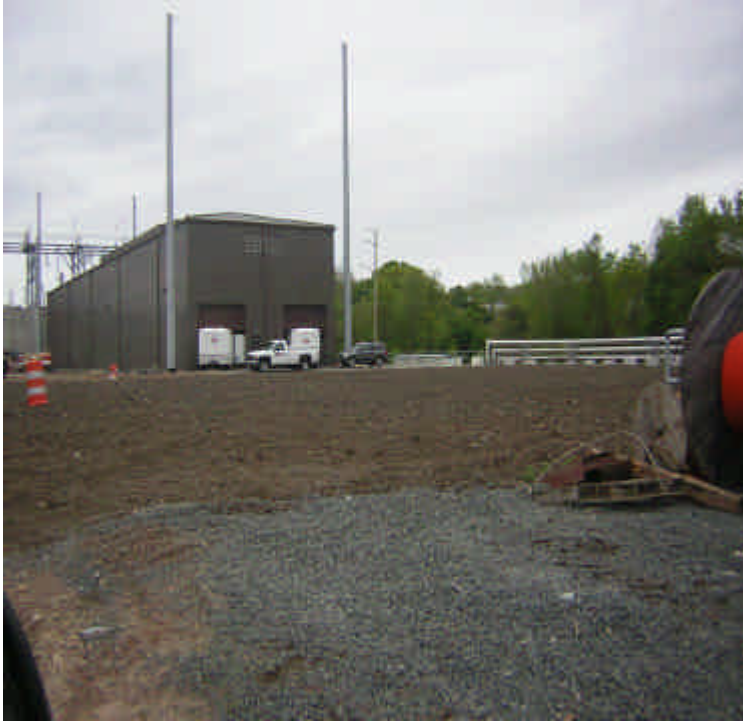
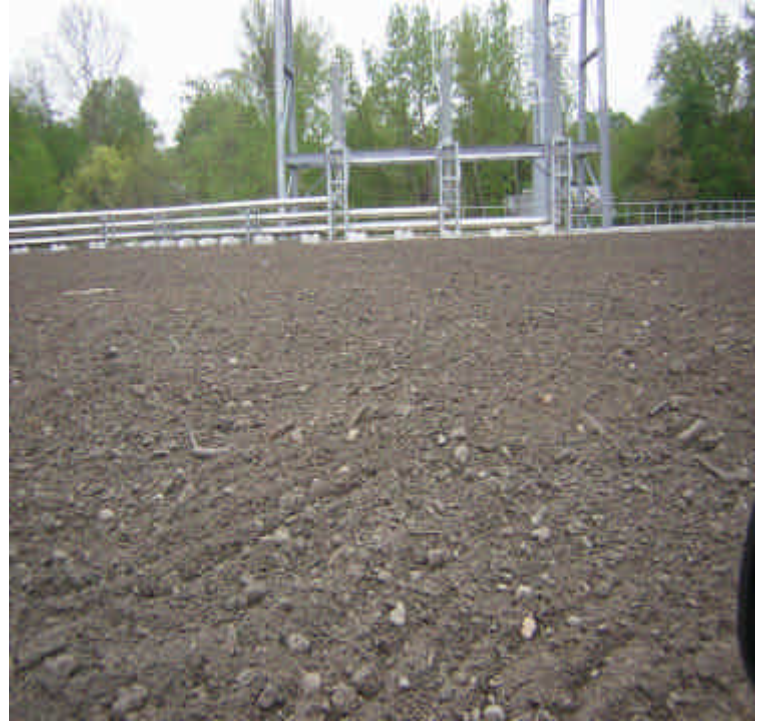
Norwalk Substation: Photo on the left shows an overall view of the yard with the recently spread topsoil. Photo on the right shows a close up view of the area recently dressed with topsoil. 5/10/06.

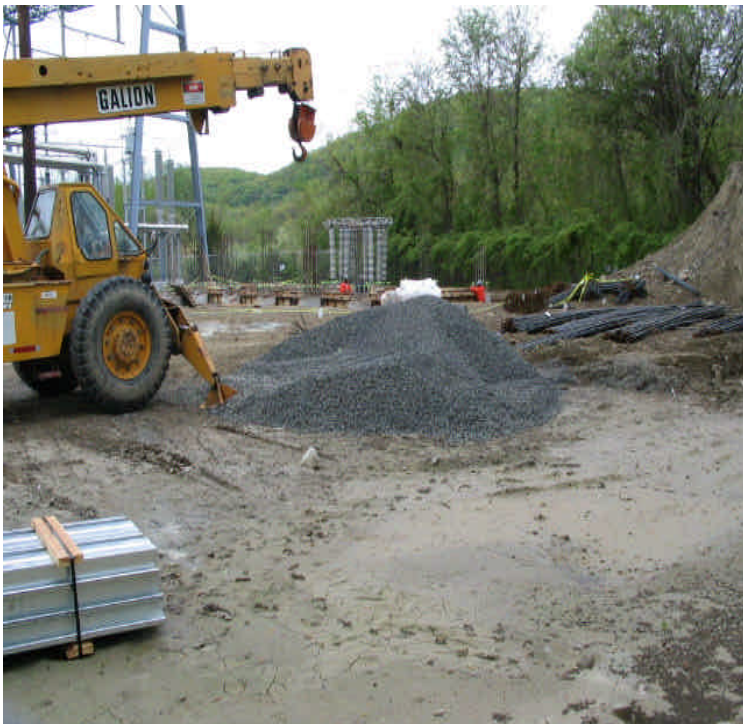
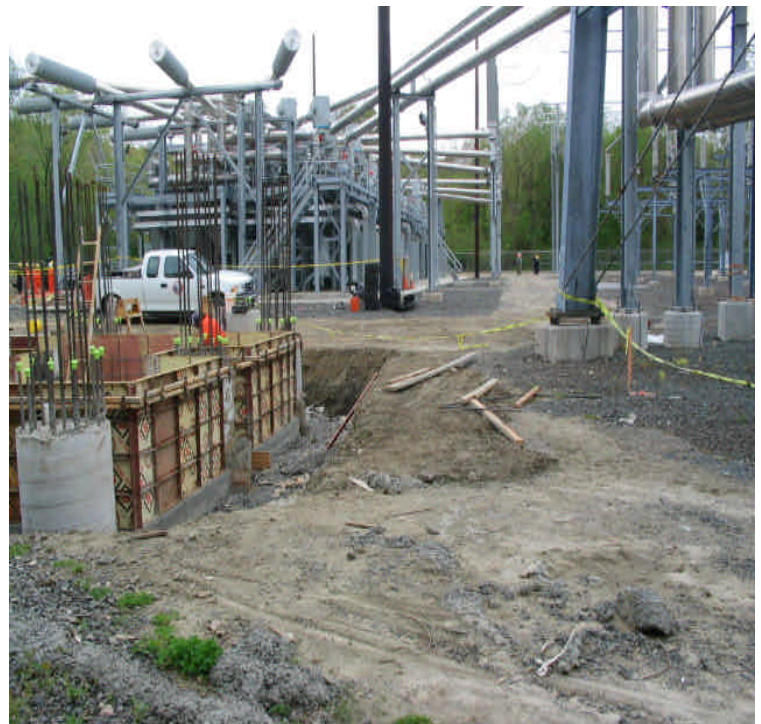
Plumtree Substation: Both photos show the ongoing excavation and foundation work in the yard. The yard remains contained but continue to monitor the larger stockpile towards the rear of the site due to its proximity to the perimeter fence. 5/10/06.
